**Chautauqua County's  
Marden E. Cobb Waterway Trail  
Past, Present & Future  
2025**

**CHAUTAUQUA  
WATERSHED  
CONSERVANCY**

This document provides an overview of the work that has been carried out in Chautauqua County's major waterways in recent years, specifically in the section known as the Marden E. Cobb Waterway Trail, to improve safety and hydrological functionality, but also to prepare for future activation. Aspects of the region's history, geology, and ecology, as well as practical information on the system's infrastructure and its challenges, are summarized here to provide a starting point for future work. Recommendations for the next steps in restoration, activation, and resiliency improvements are provided also.

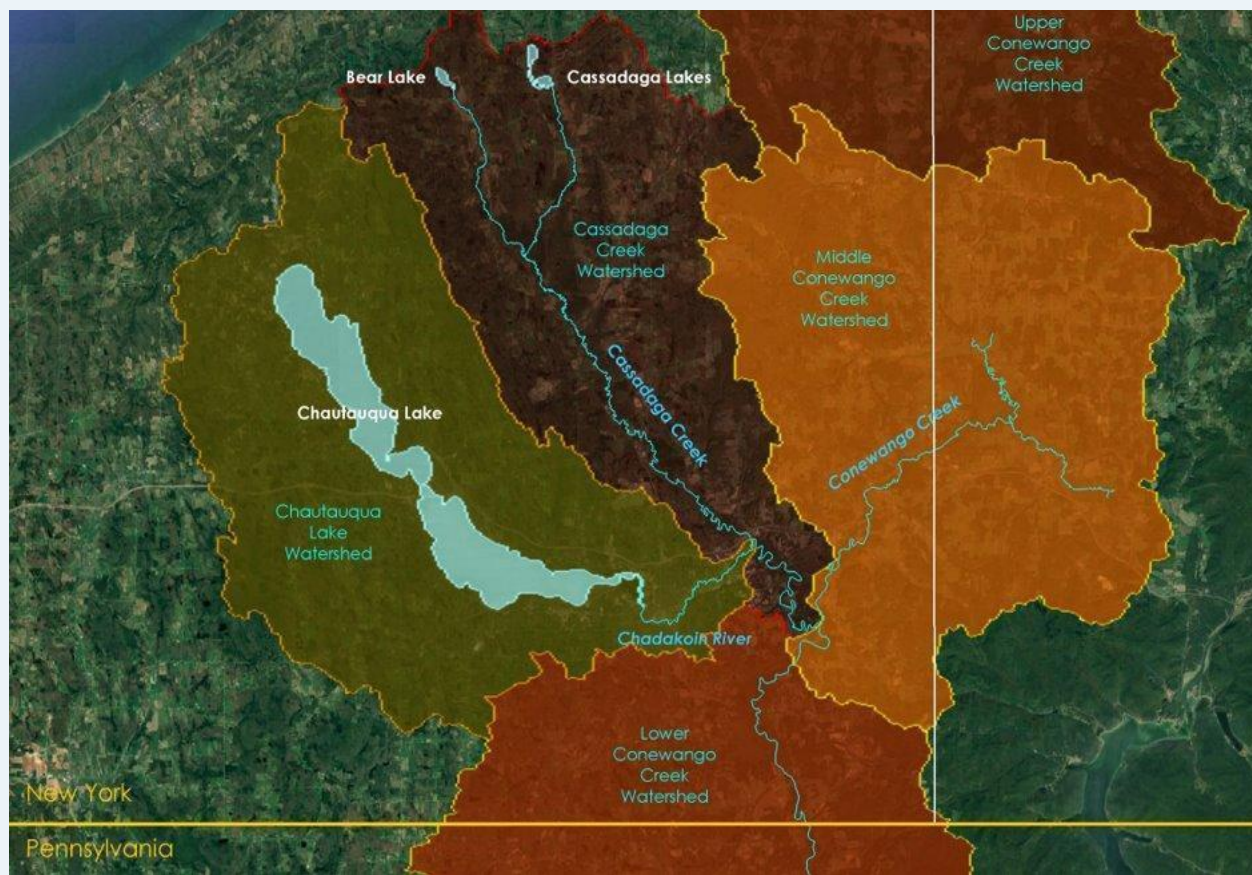
*Map of the Conewango Creek Watershed, outlining its various sub-watersheds. The entire watershed, before it drains into the Allegheny River in Warren, PA, covers almost 900 square miles. Approximately 587 square miles of that are located within Chautauqua County, all draining towards the lower Conewango Creek. Given the amount of water that collects over such a large area, it is not surprising that the lower sections of the watershed see dramatic changes in water levels at times – including normal seasonal and stochastic storm-related flood events (see example below of flood stage Conewango Creek as seen from the Riverside Road bridge in Kiantone), versus summer level flow.*

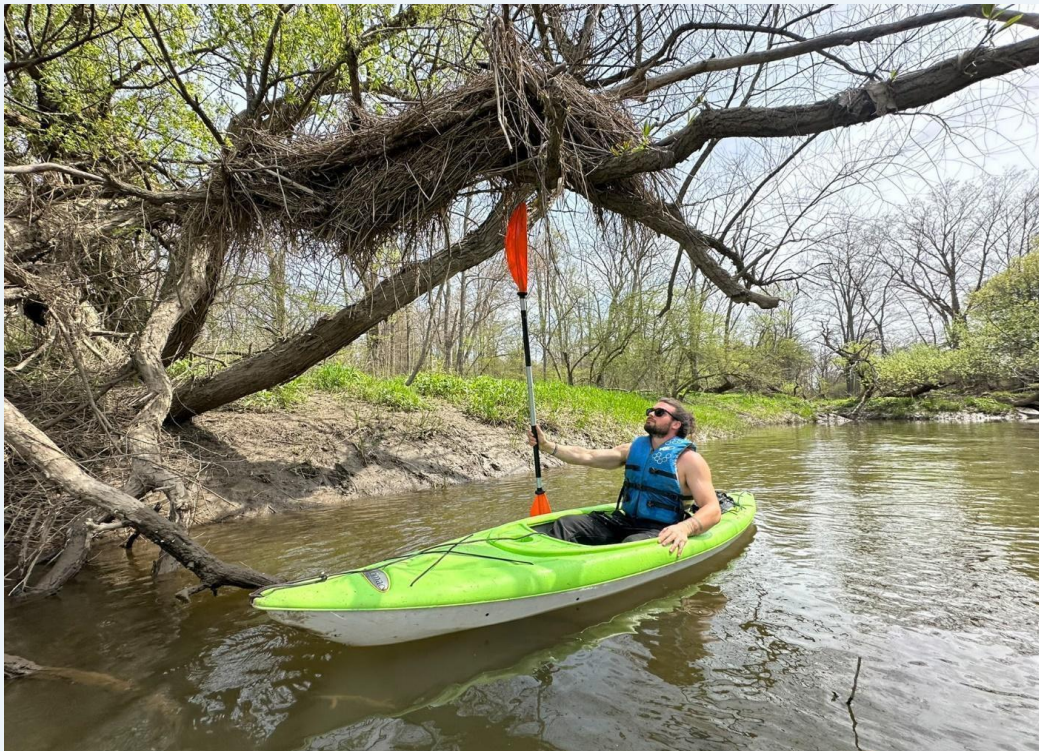
*Note the location of the wrack line, indicating the high water mark. Water levels in the county waterways can change dramatically and dangerously between seasons and after storm events.*

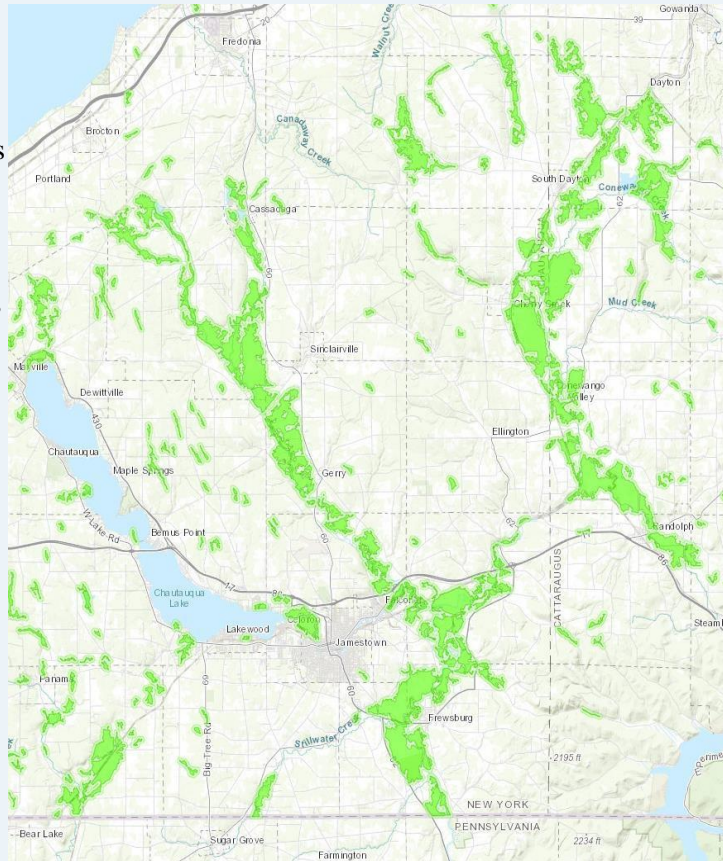
*New York State Department of Environmental Conservation's Environmental Resource Mapper Tool. Note areas along the Cassadaga and Conewango Creeks include extensive amounts of protected wetlands depicted in green*

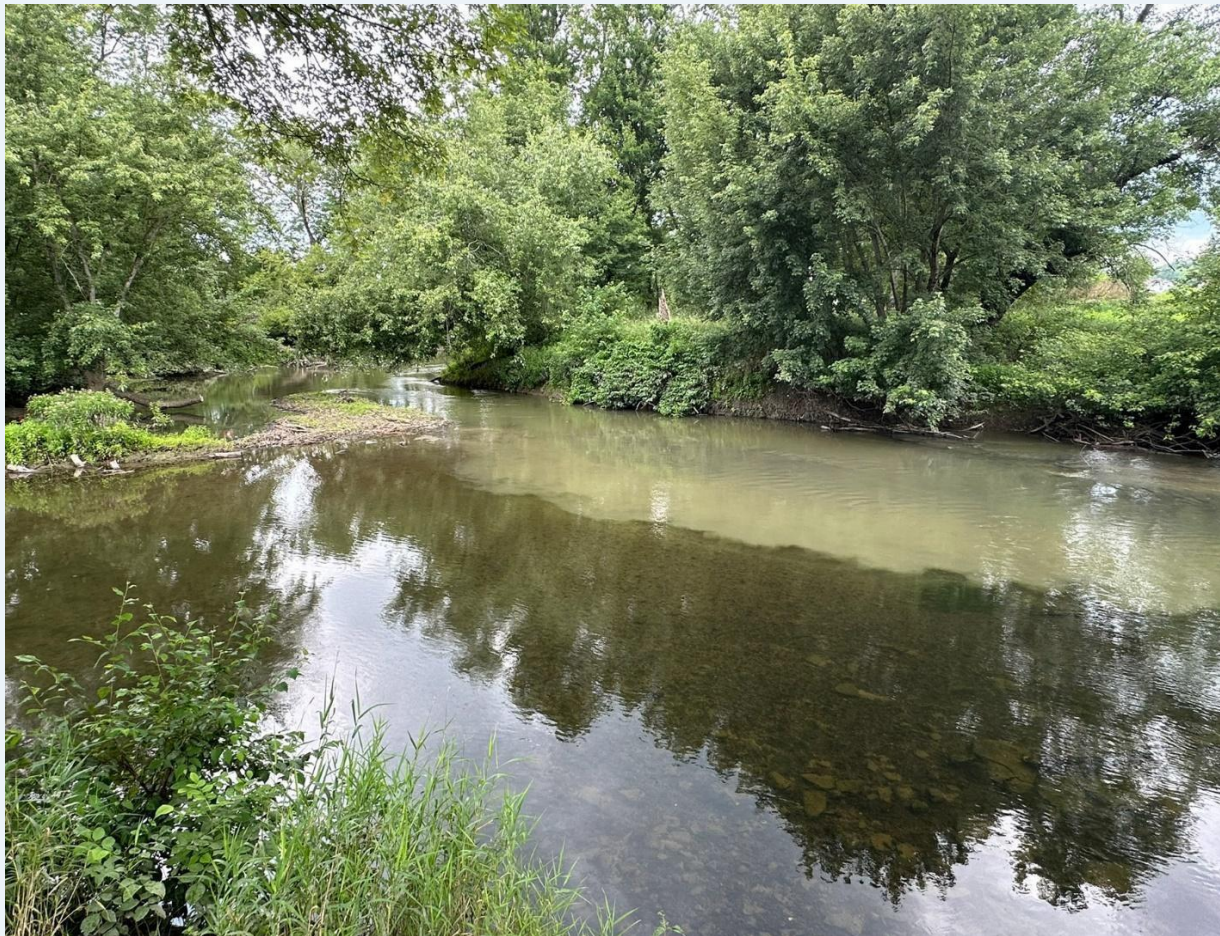
*The confluence of Chadakoin River (entering from the left) and Cassadaga Creek (enters at the top of the image & exits at the right). Note the cloudy appearance of the water in Cassadaga Creek, the result of fine clay particles naturally washing out of the creek bed and getting suspended in the water column. In contrast, water entering from the Chadakoin River appears clear and does not appear to flow through natural clay deposits. Downstream from this confluence, the waters mix and become murky again.*

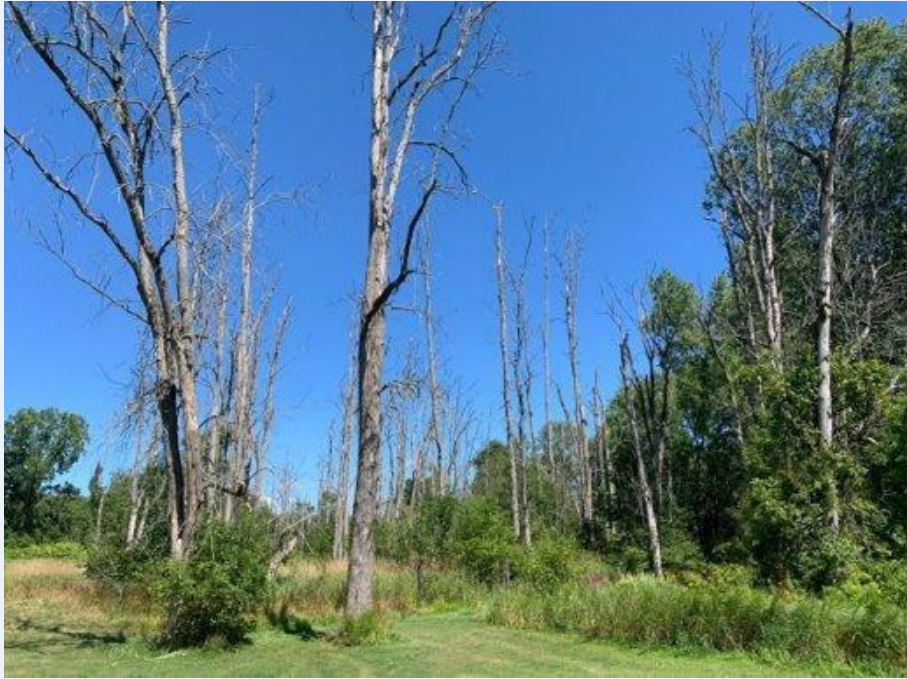
*Standing dead ash trees, the result of a region-wide infestation by the harmful forest pest Emerald Ash Borer (EAB). Since almost 23% of our local trees are some type of Ash, the arrival of EAB and the loss of almost 1 in 4 trees has severely impacted our landscape and our waterways in the past decade.*

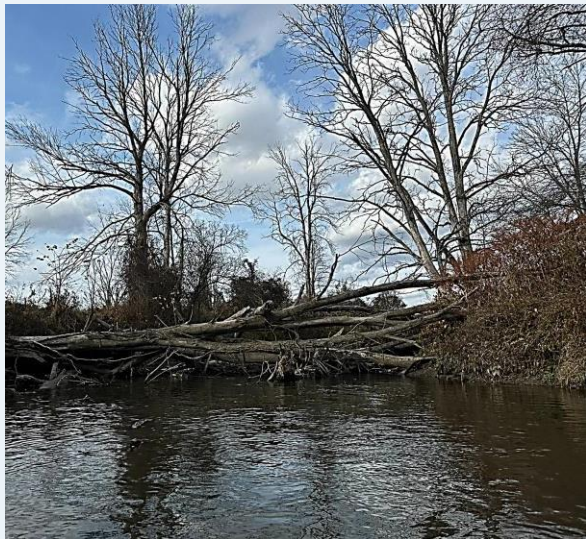
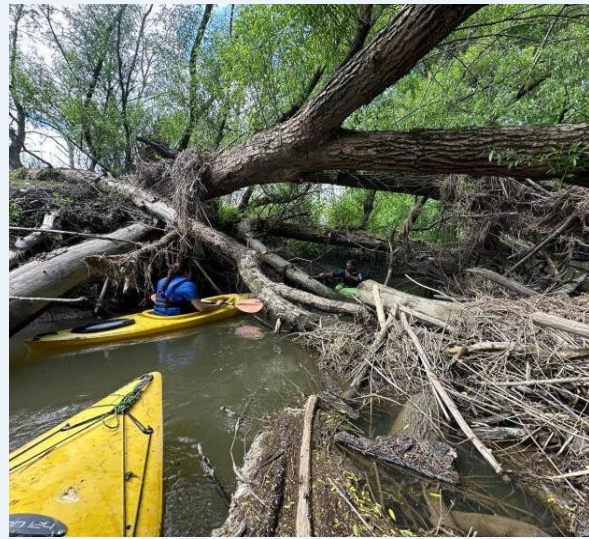
*Major Blockages on the creek as a result of downed trees – many of which are fallen dead ash trees, but also silver maples and willows that naturally grow along the banks but topple because bank erosion undercuts their roots.*

Chautauqua County's Marden E. Cobb Waterway Trail consists of a series of launches and lean-to's that once provided the infrastructure used to activate these major waterways, but long-term lack of maintenance, and the added challenge of tree die-offs have created log jams, navigational hazards, and obstructions to the healthy flow of the creeks. One of the main issues plaguing the waterways in recent years has been the blockages caused by fallen trees. Given that a large percentage of the waterways are in forested areas, this is likely to always be an issue to some extent. However, with the emerald ash borer's (EAB) discovery in New York in 2009, a large majority of ash trees in the state have been infected and died. This is a significant issue as over 8% of New York's tree population were ash trees. Since the arrival of the EAB, ash trees have consistently caused issues in New York's waterways as they die and fall or roll into the water. These trees tend to be large and often become wedged in the waterways, meaning that as more trees and other debris float downstream, they are also caught in the blockage, now creating ever-growing hazards that require human intervention to be removed. This is an ongoing battle on the waterway trail that is expensive to fix. Excessive levels of snowmelt and stormwater cause drainage issues for the waterways and increase the potential for erosion. Building hydrological resilience will be important in the future as changes to the climate and resulting changes to storm intensity occur. Looking at these issues, some may suggest that trees near the creeks should be removed to avoid them falling in the future. This solution is not entirely feasible as the trees that grow on the banks of the creeks are a significant factor in keeping bank erosion at bay. Without the roots holding the banks of the creek in place, many areas would experience significant erosion, ultimately creating even larger issues. On top of that, removing these trees would be costly in its own right. At the moment, the best option is to work through sections of the creeks one at a time to clear them enough that nothing else will become stuck. Removing legacy hazards will ultimately reduce yearly maintenance needs in the future.

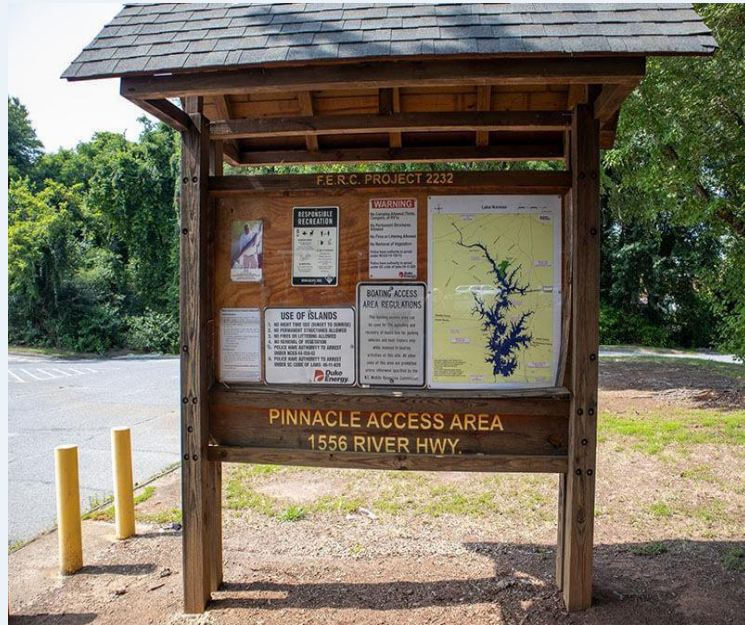
*Example of a kiosk from Pinnacle Area on Lake Norman, NC. Image courtesy of The Best of LKN*

Kiosks could include information about things such as the last time hazards were cleared in that section of the creek, things to look out for along the way, information about interesting or unique features, plants, or animals, safety tips, and a phone number or link to a place where hazards can be reported. Additional signage could be used to help visitors find the launches. On the water itself, there currently aren't any way markers for paddlers to know how far they've gone, how far it is until the next launch, or even if they are still on the creek they thought they were.

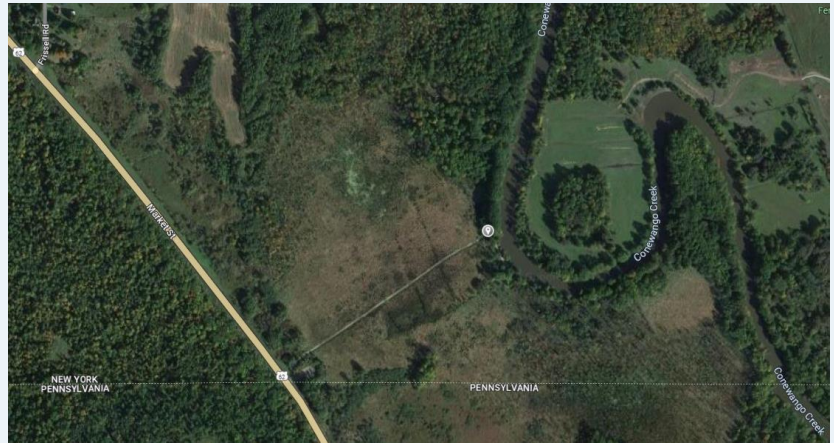
### **1. Rt 62 / PA Line Launch (Conewango 0.8 mi) (42.002582, -79.153123)**

This site is located just north of the Pennsylvania line and separated from Rt 62 by a large, county-owned wetland system. This is a popular launch site and sees significant recreational use, both for people going upstream onto the Marden E. Cobb Waterway Trail and for people going downstream into PA. Nearby canoe/kayak rental outfitters routinely drive customers to this site to put in and have them take out at a variety of downstream locations.

Access to the launch site is restricted by a gate near Rt 62, which is seasonally closed during the fall/winter/spring when Conewango Creek and its floodplain tend to flood and submerge the access road.

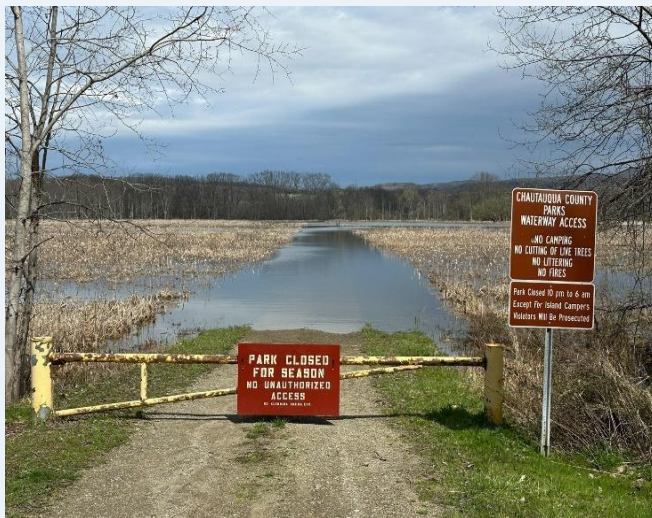
The launch site can be reached by car when the main gate is open, and ample parking space is available. The site has a few benches overlooking the river. The actual launch is essentially a series of wooden steps and platforms that step down from the top of the bank to wherever the creek's water level is at a given time. Due to the seasonal flooding, the entire structure is underwater each spring, while even the bottom platform may be hard to reach while sitting in a kayak during a dry summer's low water conditions (**see picture**).

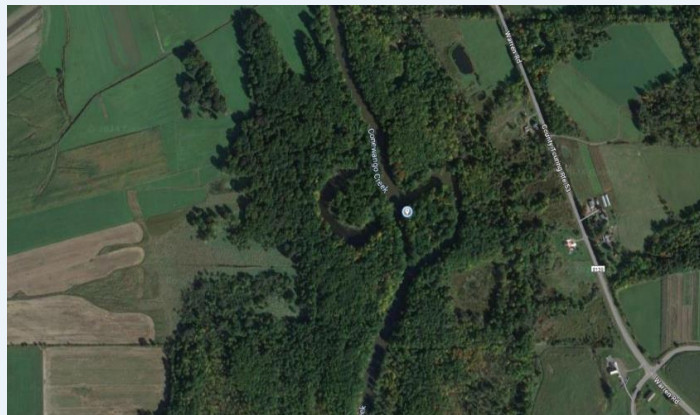
This is a county-owned campsite and lean-to located on “Clam Island”. It can only be reached via boat, and there once was a launch on the island, but that has washed away with only a few metal pipes remaining (see photo).

Visitors beach their canoes or kayaks either on the south side of the island or near the lean-to on the northern side of the island. A very large log jam on the north side of the island has blocked the oxbow that wraps around the east side of the island, but the main channel of Conewango Creek has been cleared and is accessible. Several recent tree falls along the northern,

upstream face of the island have led to the formation of the logjam in the oxbow, as much of the lumber was pushed into the channel from the main stem of Conewango Creek. The loss of trees has now left the northern shore of the island exposed to strong currents, and the bank is caving in rapidly, potentially

threatening the lean-to in the near future. Sediment that has fallen off the face of the island now forms a flat beach where visitors park their boats, but it also creates a hydrological modifier that causes strong currents during the winter months to scour away at a higher point on the bank, thus exacerbating erosion and sediment loss. Some type of rock armoring and bank stabilization efforts would be very beneficial but may not be logistically feasible given the lack of equipment access to the site.

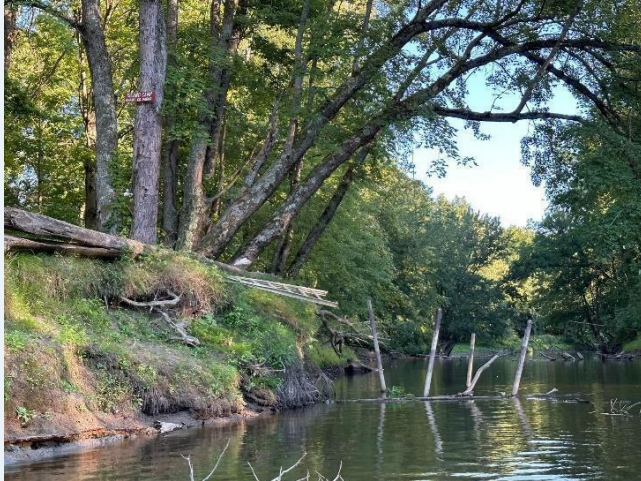
*Remnants of the island camp's boat launch*

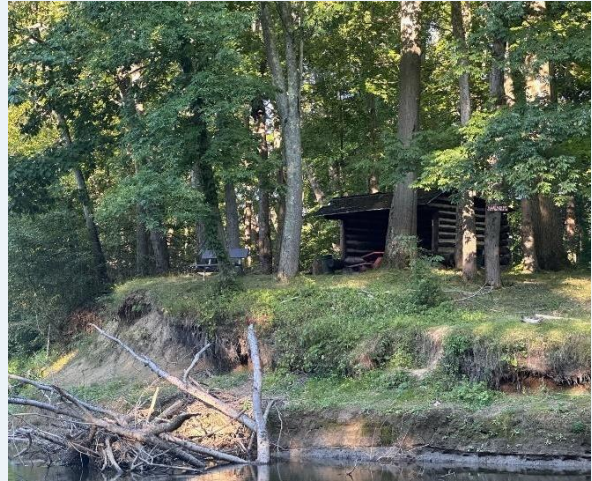
*Eroding exposed face of the island & lean-to*

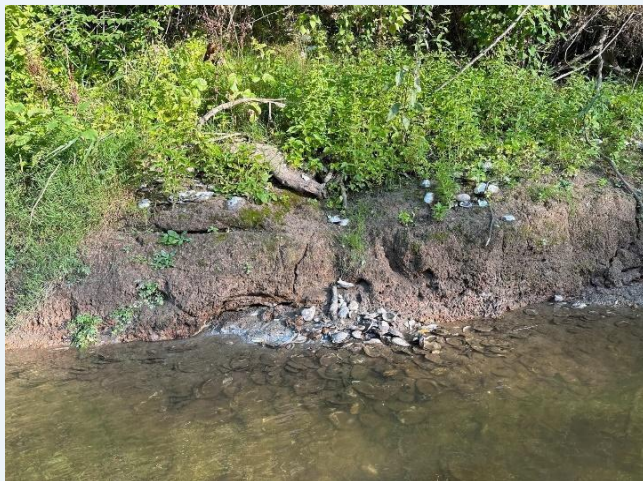
*Partially exposed native mussel mound,  
possibly a Native American archeological artifact.*

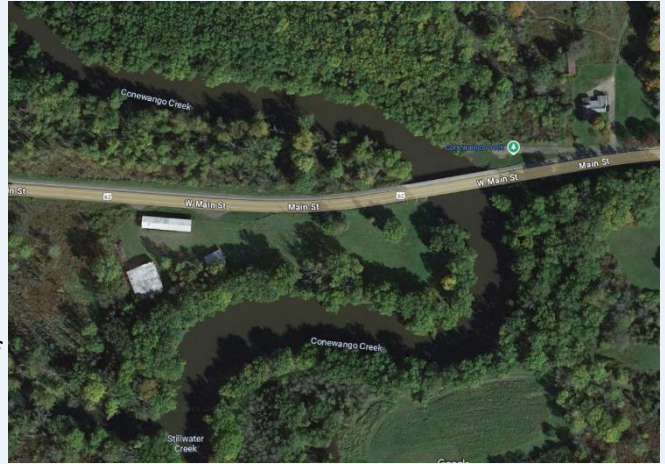
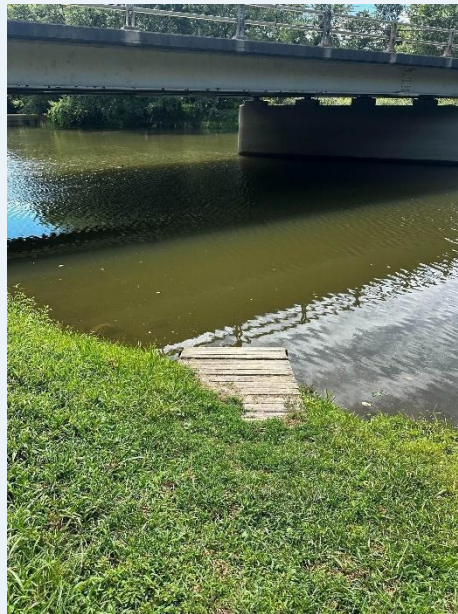
The actual launch is minimal and consists of a small wooden platform on the edge of the creek (see photo) that is located at a decent height to accommodate paddlers during the lower water levels experienced in the summer, but with even slightly elevated water levels in the creek, this platform will be underwater. This launch site provides good opportunities for both upstream and downstream trips.

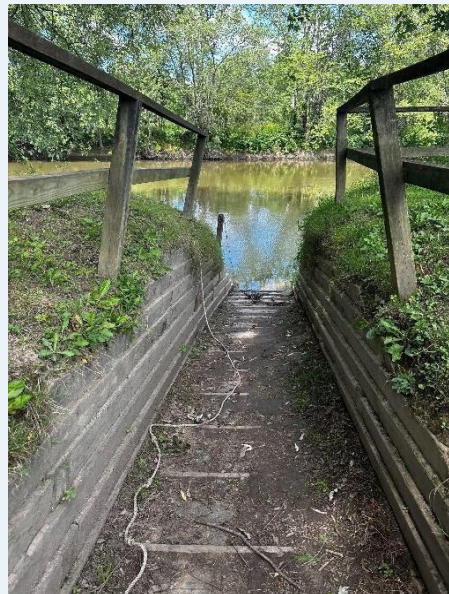
Mud building up on the walking surface during a period of highwater can make the launch dangerously slippery. A rope has been tied to the top of the walkway to provide a handhold (**see photo**), as the walkway is barely walkable once it is caked with slippery clay. The narrow cut into the bank makes it difficult to walk down this launch while carrying a kayak, as the width is not adequate. This launch is well-positioned in the waterway trail to accommodate wonderful canoe or kayak trips on the Conewango Creek, but it could benefit from some upgrades to the infrastructure.

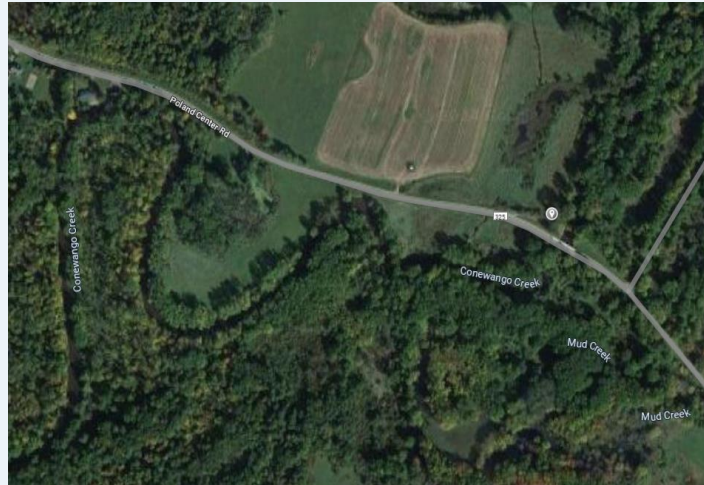
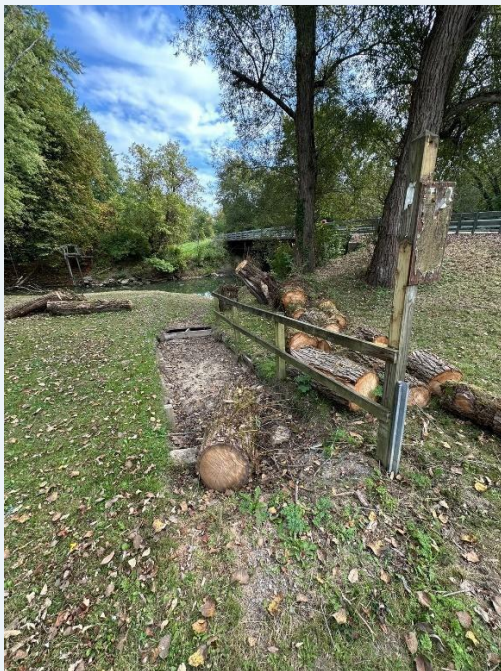
This is the only county-owned launch in the upper Conewango Creek, upstream from the confluence with Cassadaga Creek. It is a small pull-off on the north side of Poland Center Road, near the bridge that spans Conewango Creek. The pull-off provides plenty of room to park several vehicles. This launch consists of a wooden plank walkway that slopes down the bank. The surrounding area is a mowed grass clearing. A handrail follows the walkway down to the water's edge on one side. This launch was recently damaged by falling trees, which have been cut up and moved off the path, but the logs are still present (**see photo**). Damaged sections of the wooden walkway have been removed but not replaced. This is a pleasant and usable launch but is due for some maintenance.

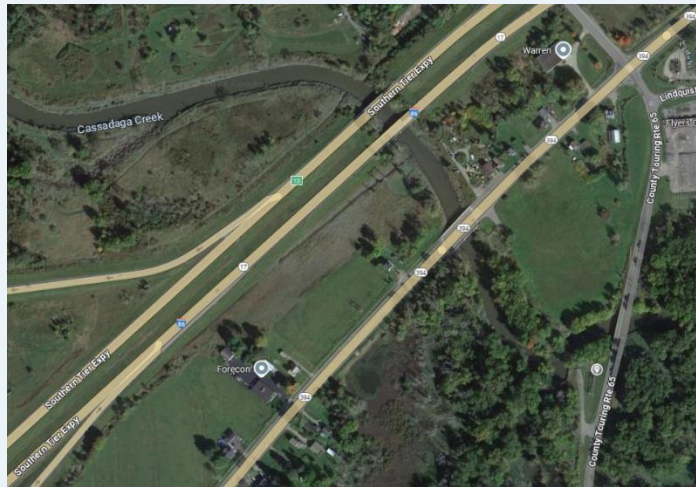
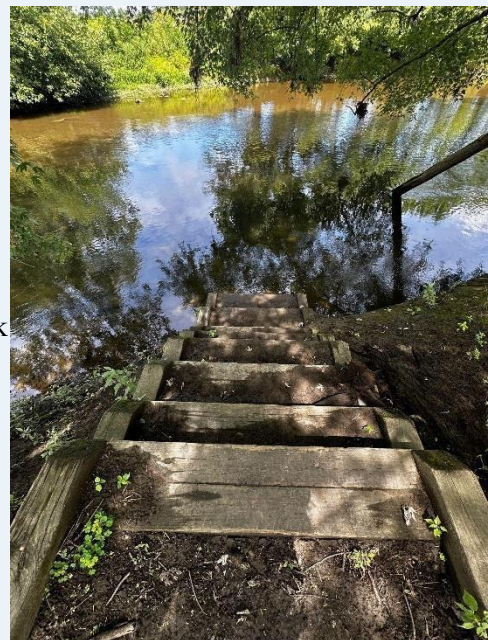
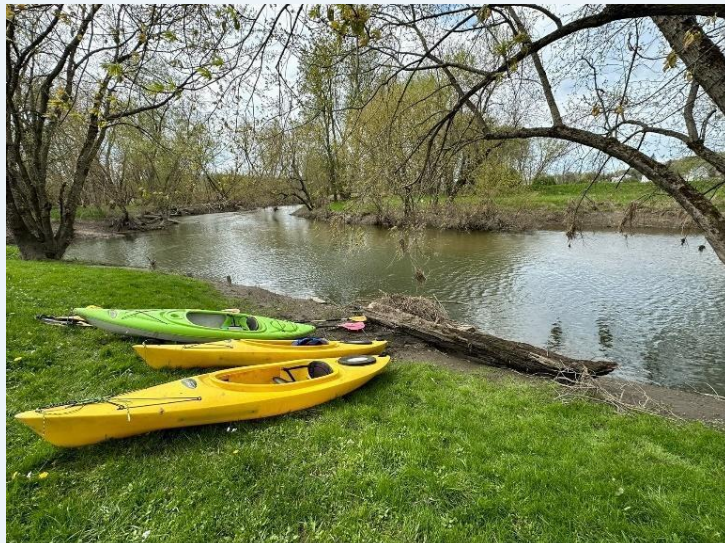
This launch is located off Gerry-Levant Road, between Rt 394 and I-86. The site is marked by an old bridge frame that is located next to the large gravel parking area. A sizeable grassy area provides space for a picnic and offers nice views of the Chadakoin and Cassadaga Creek. Due to the large volume of water that converges here in early spring, after snowmelt events, or during big rainstorms, this entire launch can be underwater at times. The launch itself is small and consists of a series of fairly steep wooden steps leading down from the grassy knoll to the water's edge. The steps extend far enough to make them usable at a variety of water levels, but, like other launches, they get covered in thick slippery clay after high water events, making them treacherous to navigate.

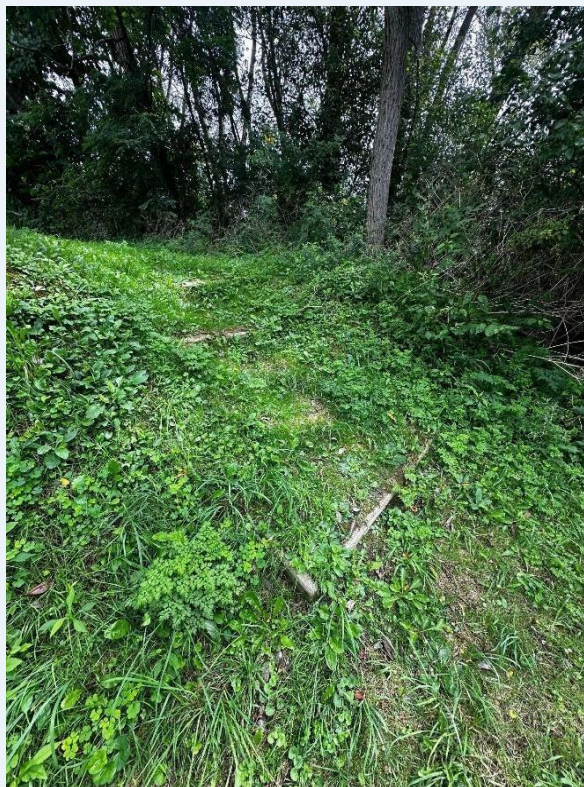
It appears that steps were once present, but they are now covered with grass, creating a steep and slippery descent to the water's edge (*see photo*). The lack of a suitable walking surface is creating some erosion issues, and the exposed sediment also makes the walk down the banks even more slippery under wet conditions. This is an important launch point in the waterway trail system, especially now that Cassadaga Creek has recently been reopened to recreational uses. However, some upgrades to the infrastructure are needed.

*Remnants of steps are still visible.*

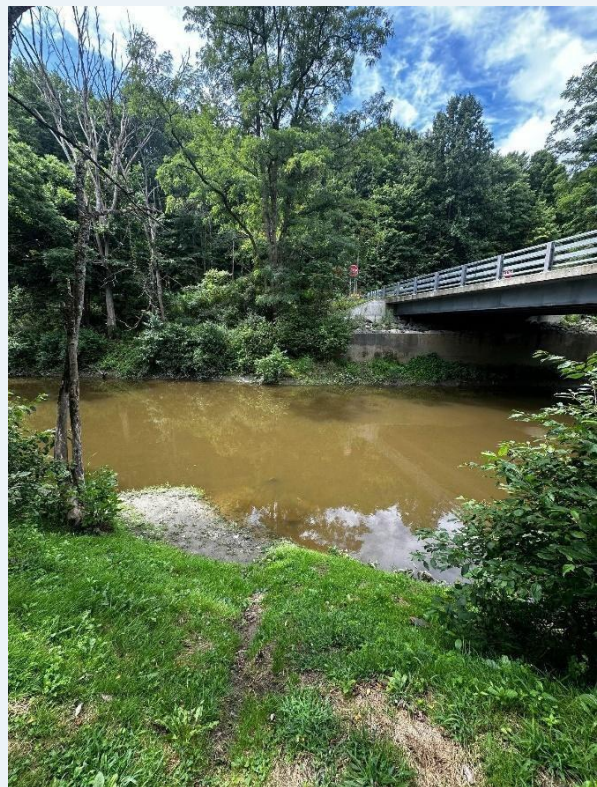
*Muddy path down to the creek.*

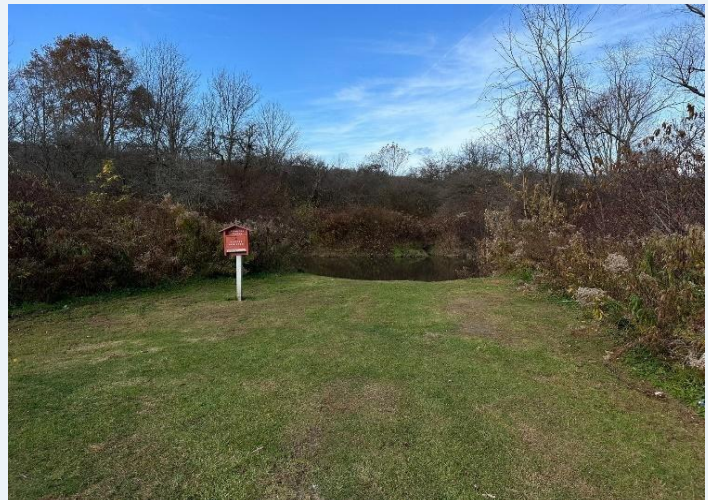
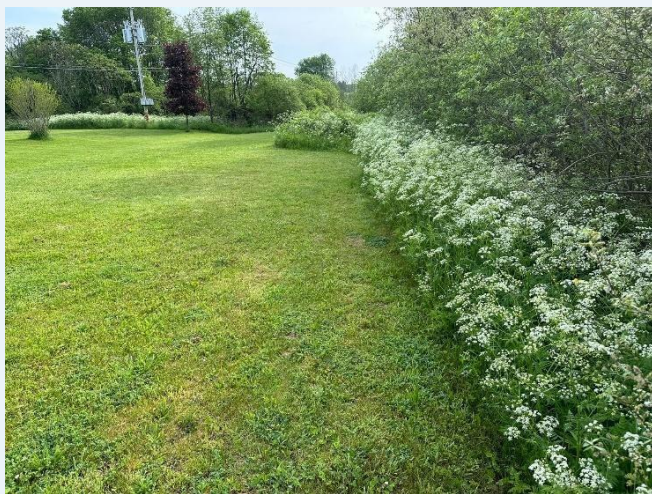
This is one of the most visible Marden E. Cobb Waterway access points. It's located on the very busy Rt 60 corridor in Gerry. Unfortunately, marked by an uninviting foundation slab near its entrance, the grassy launch area is pretty and provides plenty of space for several vehicles. There is no platform or other infrastructure provided to safely launch a canoe or kayak, and the launch area is simply a steeply sloping bank covered in lawn. Because of its accessibility and visibility, this is one of the more frequently used launches, but unfortunately, this is also one of the hardest-to-use water access points. The lack of any structures along the water's edge, combined with the very steep and exceedingly slippery slope towards the water, makes safely entering the water with a boat nearly impossible. During the project period, several people have been seen sliding down the bank and falling into the creek or flipping their boat trying to exit as there is no secure footing and nothing to hold onto. In fact, it is clear from existing tracks and trampled vegetation on either side of the launch area that many people have opted to bushwhack through dense pricker bushes and dogwoods to enter or exit Cassadaga Creek, rather than use the space intended for that use.

Unfortunately, this site has been impacted by the non-native, invasive Wild Chervil (*Anthriscus sylvestris*) which grows in dense stands during its early season flowering period and is difficult to eradicate (see photo above).

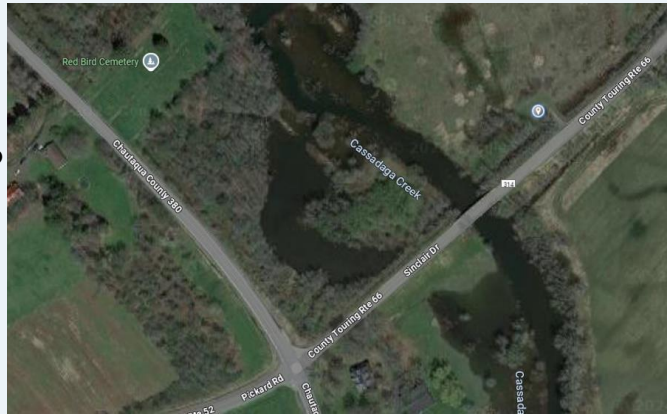
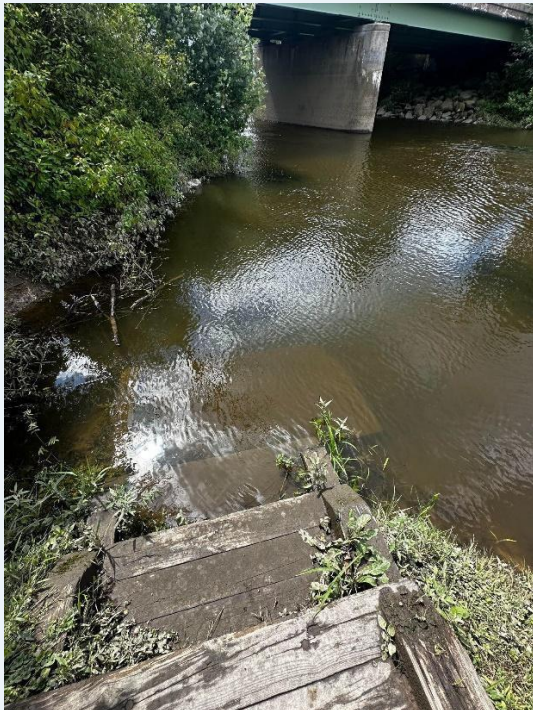
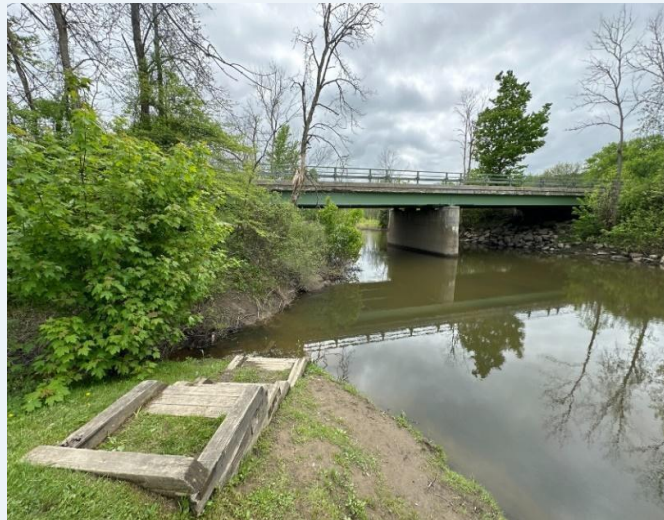
A short walking path from the parking area leads to the water's edge near the Rt 66 bridge, where a few steps and a sizeable platform provide one of the best launch experiences of any of the Marden E. Cobb Waterway's access points. A large, submersed concrete slab at the bottom of the steps (see **photo on left**) provides a sturdy and stable launching platform. Note that the steps can get slippery after high water covers them in mud. Also, the scouring action of the water is quite visible on the creek side of the steps where erosion and bank loss can be noticed (see **photo on right**), and some stabilization with rock riprap would help stabilize this launch.

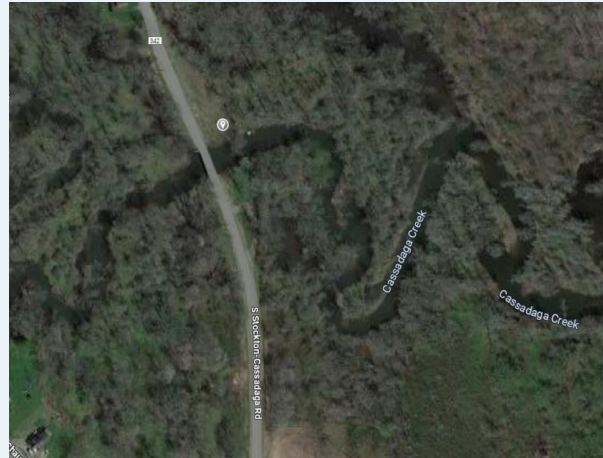
The recent (summer 2024) work on replacing the South Stockton-Cassadaga Road bridge and the associated reconfiguration of surrounding drainage has led to the complete removal of the launch area. There currently is no launch at this site, although one is scheduled to be installed at a future date.

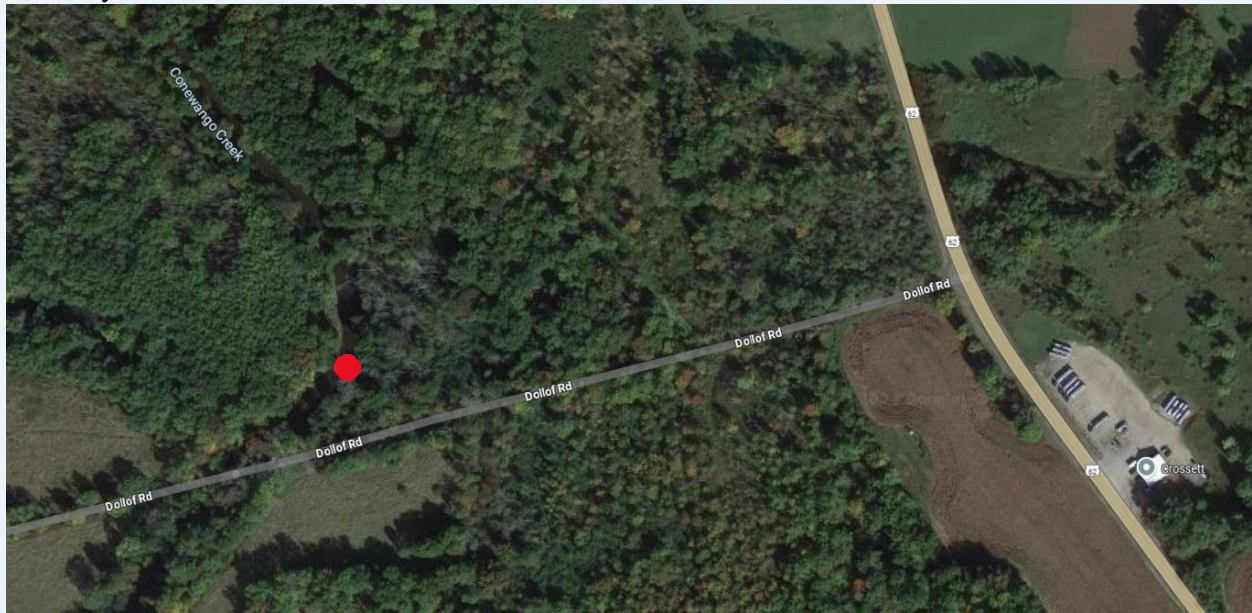
Dollof Road is no longer continuous (despite what most maps indicate). When accessed from Rt 62, Dollof Road dead-ends at a dangerously derelict bridge over the Conewango. This site is very close to the Cassadaga-Conewango Confluence (located at Conewango 11.5 mi, less than a quarter mile downstream from this point). There are very few places where one can reach this middle section of the county's waterways, and, besides (emergency) access, installation of an additional launch could be considered. The benefit of an old roadbed is significant for vehicle access. Removal of the bridge is recommended. Perhaps a launch could be constructed where the bridge is currently.

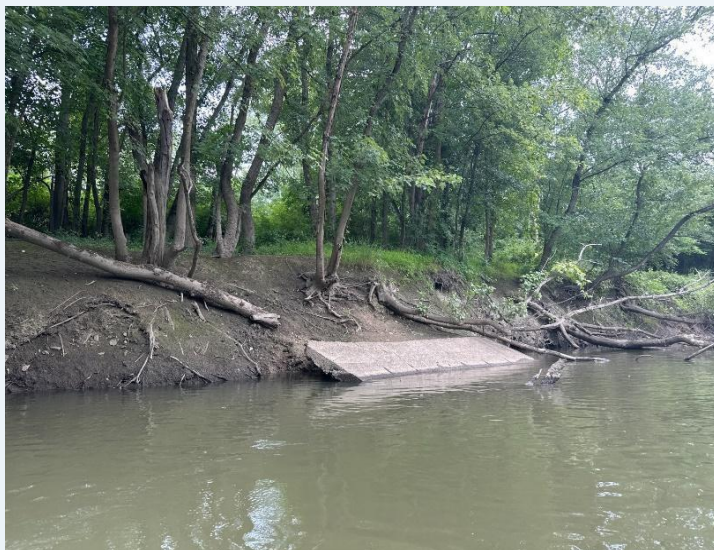
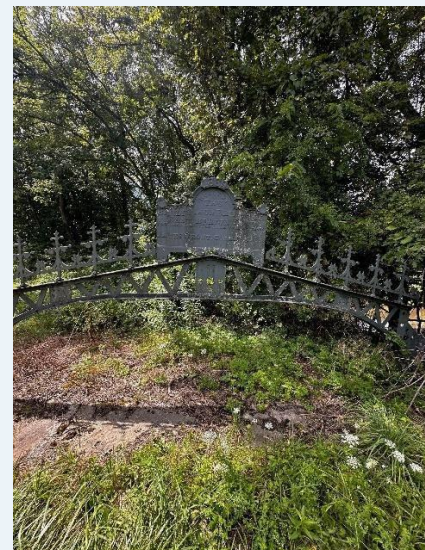
This appears to be the site of an old (now abandoned) launch. A concrete slab on the water's edge (**see photo on left**) is a reminder of prior use of this, now privately-owned, site. Emergency water access is very feasible, but this may be a site considered for a future launch. Proximity to several roads makes access very easy, but parking may not be feasible as the water level in this section of the creek rises significantly during the winter months. Some type of historic marker is present at this location (**see photo on right**).

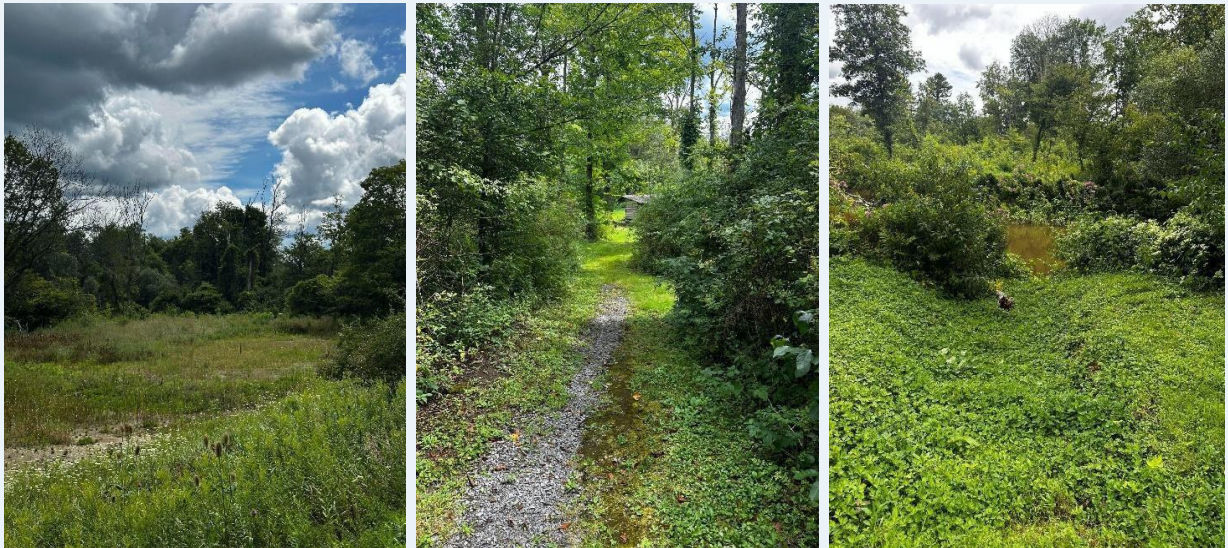
This site is the location of a county-owned lean-to. An old, abandoned parking lot exists next to the structure that could be re-purposed to accommodate additional vehicles. A grassy trail leads down to the lean-to and to the creek, where a launch site could potentially be constructed.

*The abandoned parking lot, access path to lean-to & access from lean-to to Cassadaga Creek, respectively*

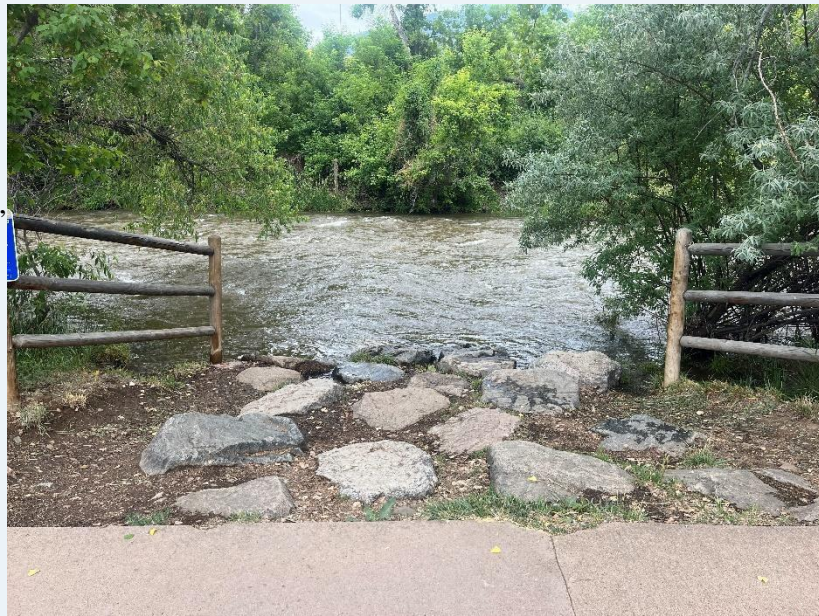
The use of large river rocks buried deeply to prevent them from eroding out of the bank matrix could be considered (**see image on right**). However, a design like this will undoubtedly result in an uneven walking surface that could lead to tripping incidents.

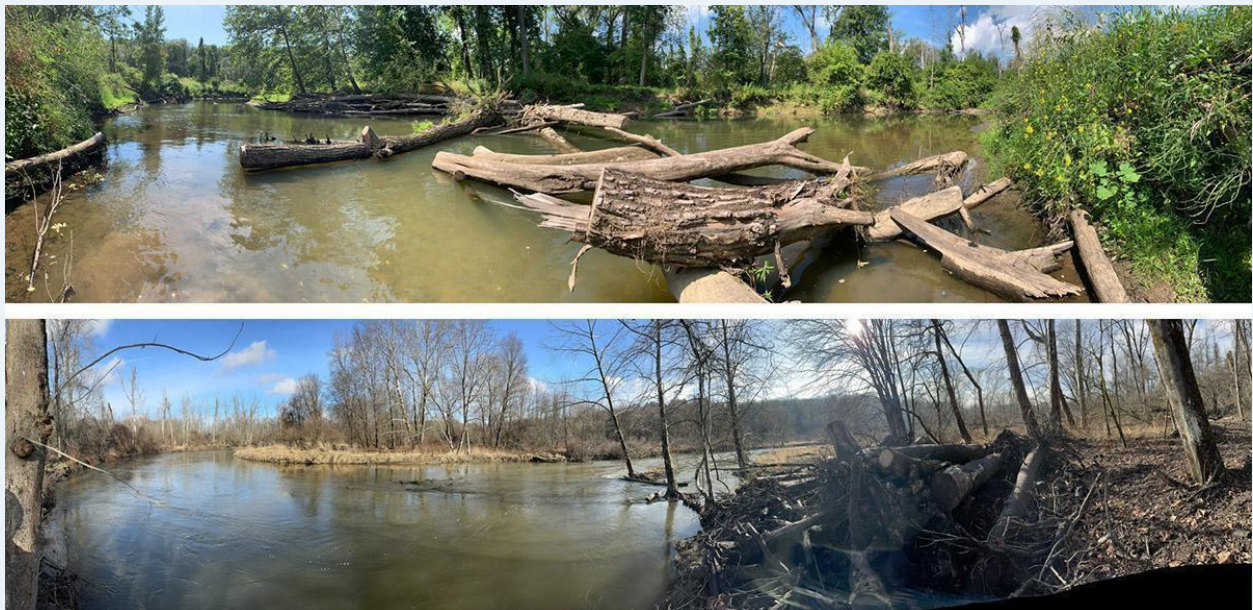
*Example of a before-after hazard removal situation on the Conewango Creek in Kennedy, NY*

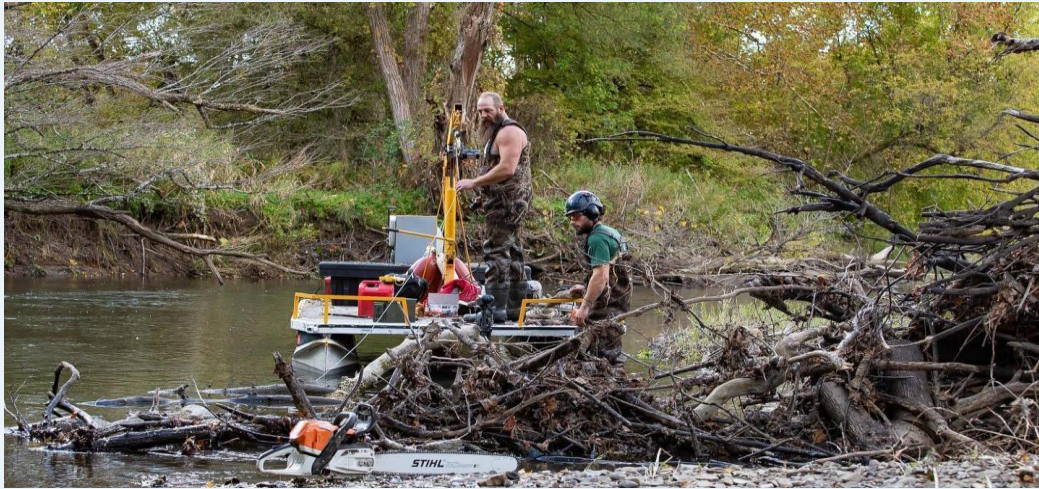
*Barge-mounted crane in use – on-water hazard removal – Upper Conewango Creek, Kennedy, NY.*

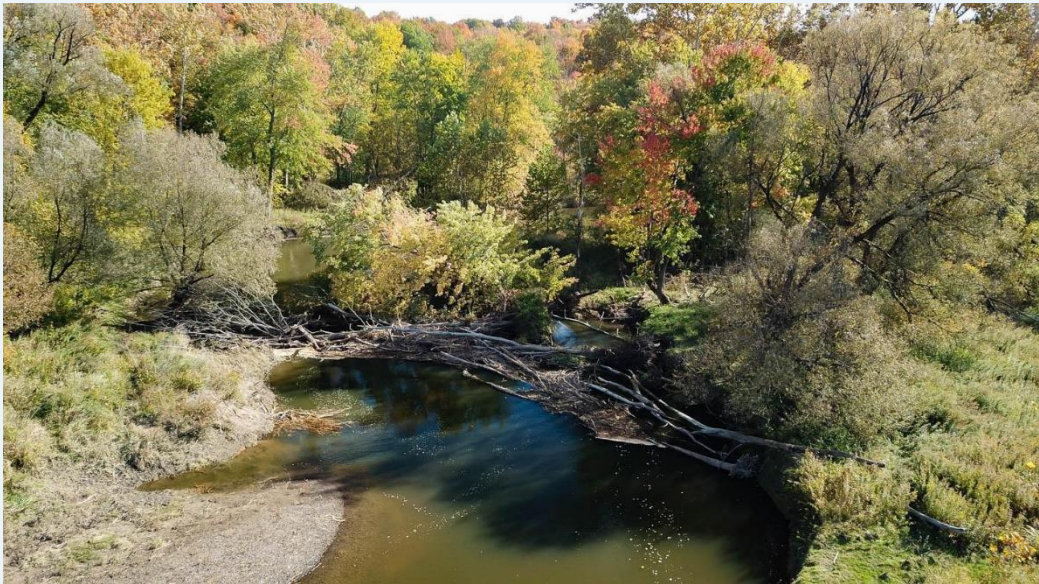
*Log jam in upper Conewango Creek – example of drone survey*

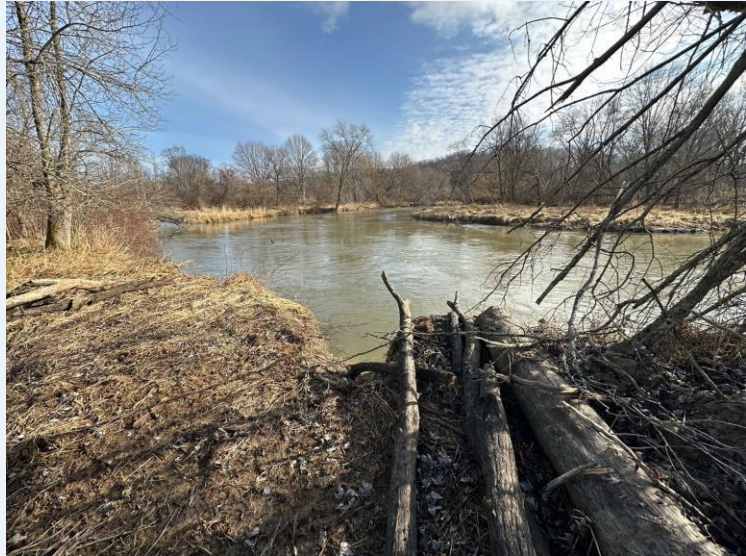
*Conewango Creek after hazard removal.*
