**Chautauqua County's  
Marden E. Cobb Waterway Trail  
Past, Present & Future  
2025**

**CHAUTAUQUA  
WATERSHED  
CONSERVANCY**

This document provides an overview of the work that has been carried out in Chautauqua County's major waterways in recent years, specifically in the section known as the Marden E. Cobb Waterway Trail, to improve safety and hydrological functionality, but also to prepare for future activation. Aspects of the region's history, geology, and ecology, as well as practical information on the system's infrastructure and its challenges, are summarized here to provide a starting point for future work. Recommendations for the next steps in restoration, activation, and resiliency improvements are provided also.

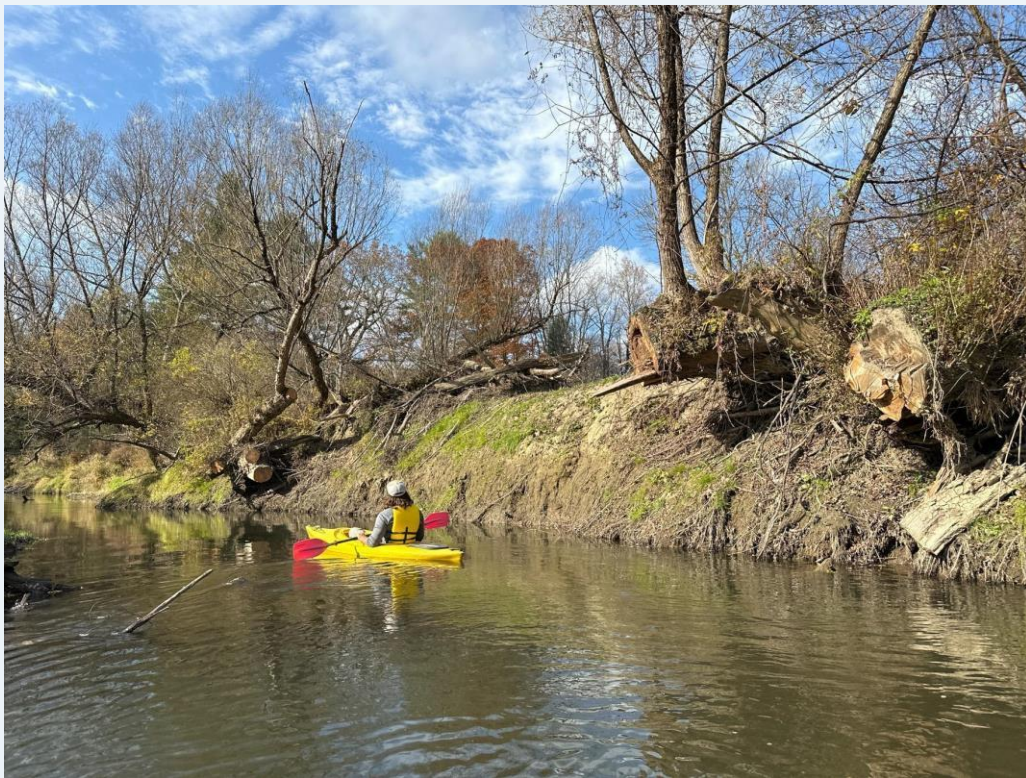
*Cassadaga Creek post-hazard removal in 2024. Note the diameter of the trees removed from the waterway.*

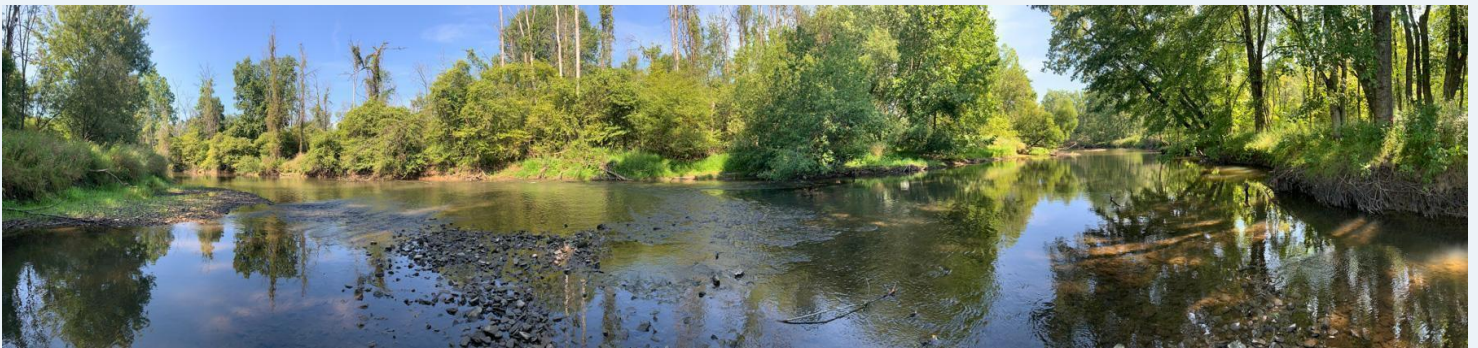
*Cleared section of the Conewango Creek flowing freely.*

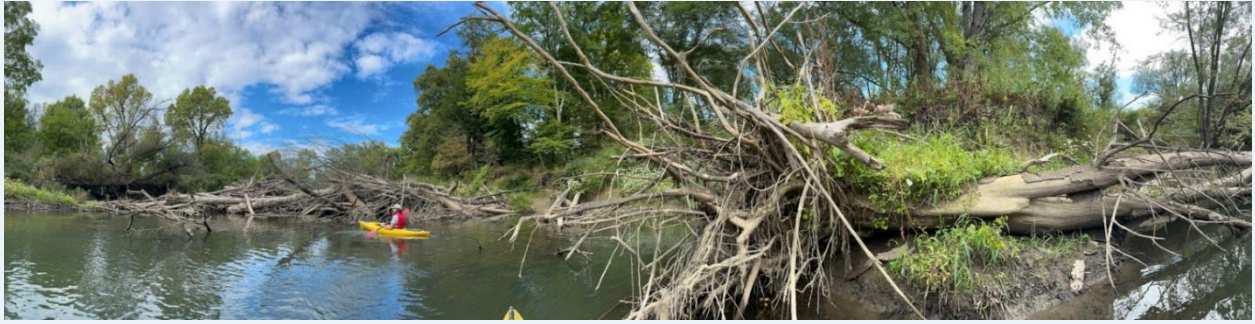
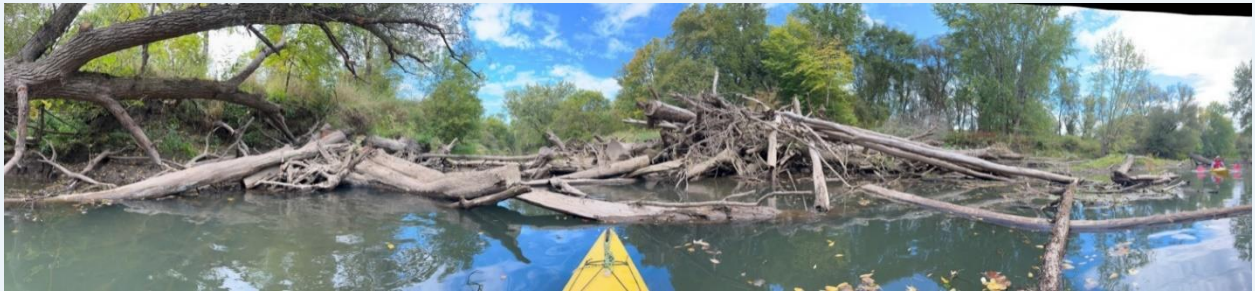
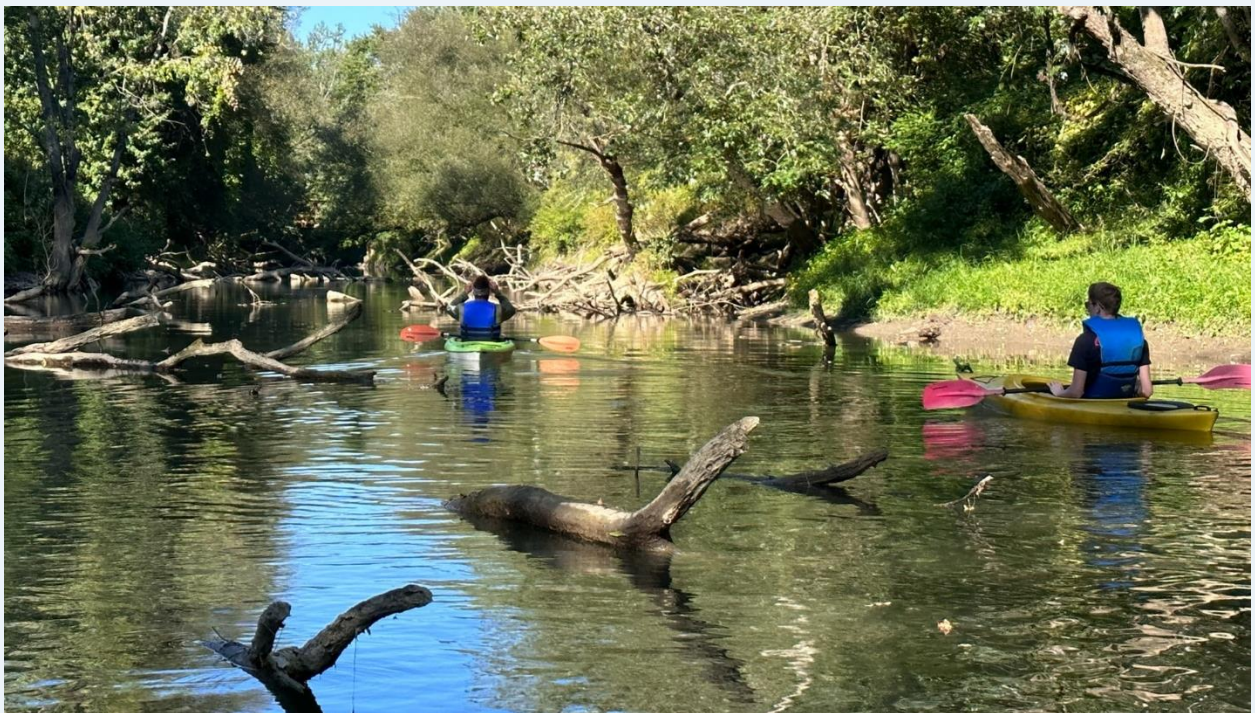
Examples of log jams in the four most severe trouble spots:

- There are 4 major areas of concern that have massive log jams (**see map above**). If equipment access (excavators) can be achieved, these can be cut up and removed from the waterways. Alternatively, if they cannot be extracted, they will need to be opened using chainsaw crews. As has been done in the past, the priority will be to restore the natural flow and allow for the safe passage of boaters. Where possible, large logs will be cut to reduce their size & allow the log jam to break up during a future high-water event. Remnant debris will be too small to create a similar jam downstream. The estimated time allocated to break up these four problem areas is 10-15 crew days.

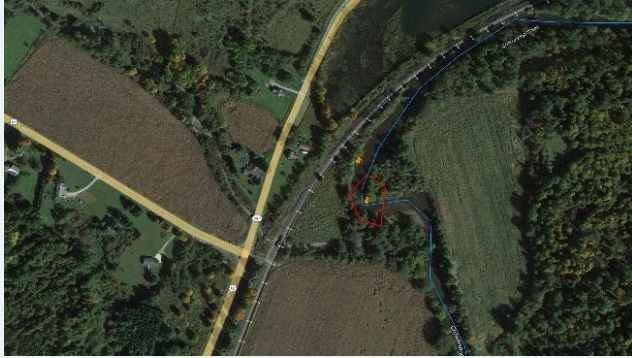
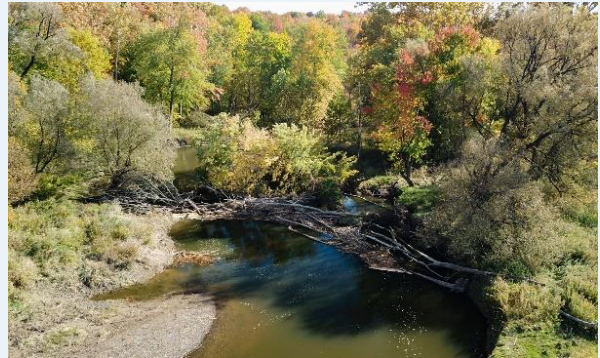
#### Kennedy

An opening was cut into this log jam in 2024 to allow for safe passage, but this log jam has already caused a massive bank collapse and will reroute the Conewango through neighboring farm fields if left as-is.

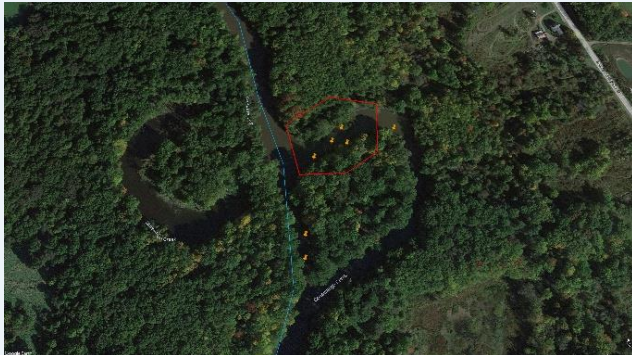
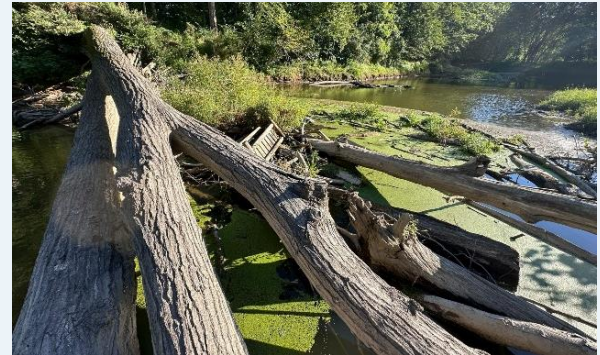
#### Clam Island

The blockage of the “elbow” east of the main stem of Conewango Creek is causing water to flow into that section of the stream and bounce back off the log jam, causing significant erosion on the upstream-facing side of Clam Island directly below the county lean-to (**bottom photo**). Restoring flow into the elbow will likely ease some of the pressure on the island & county assets.

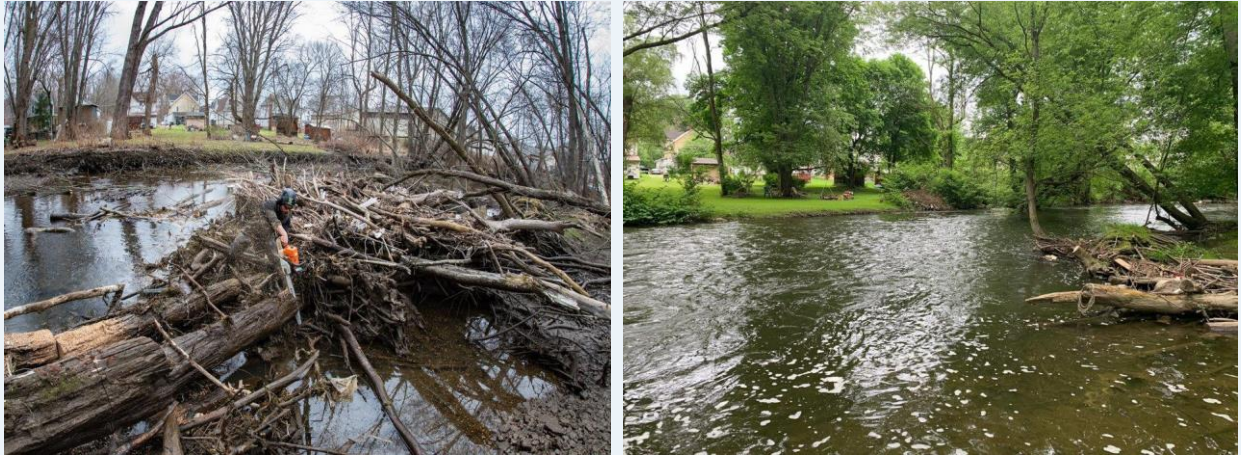
*Chadakoin River hazard removal before (left) and after (right).*

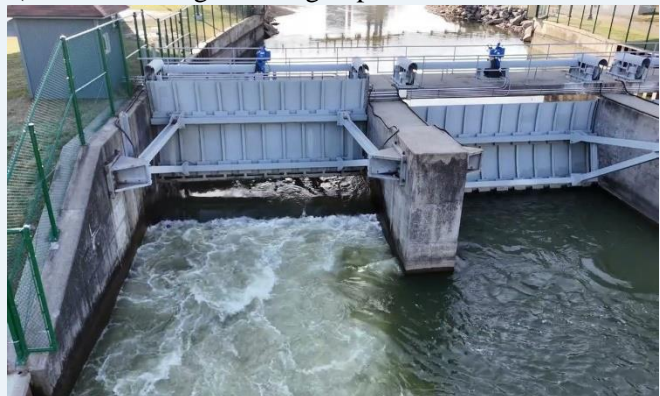
*The Warner Dam on the Chadakoin River.*

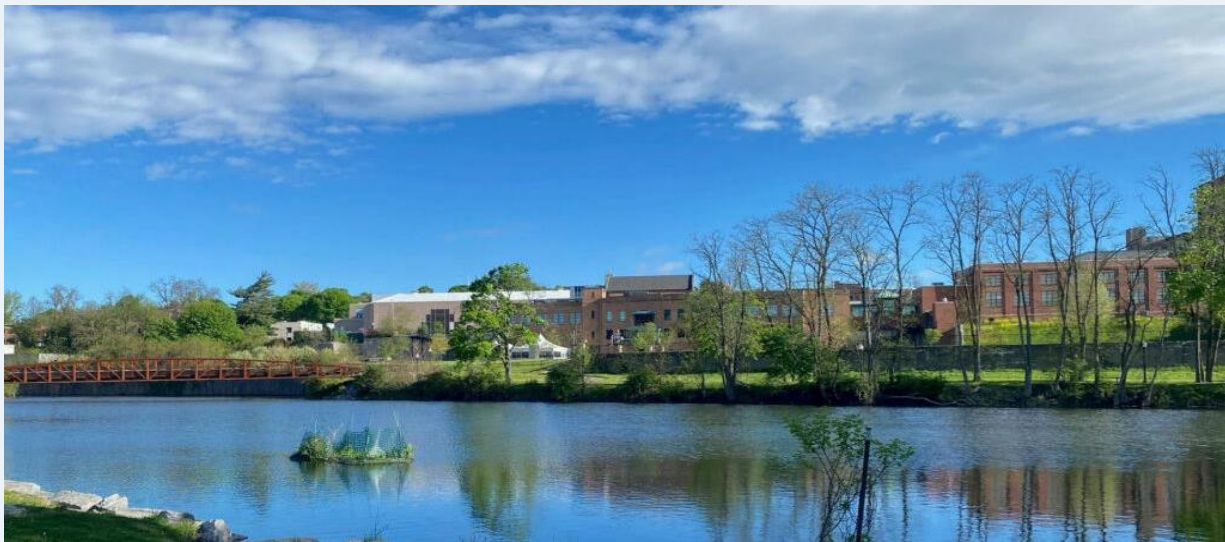
*The Chadakoin River in Jamestown, NY, and the problematic trees that have since been removed.*
